# **INDOOR AIR QUALITY ASSESSMENT**

**Duxbury Free Library  
77 Alden Street  
Duxbury, Massachusetts**

Prepared by:  
Massachusetts Department of Public Health  
Center for Environmental Health  
Bureau of Environmental Health Assessment  
May 2005

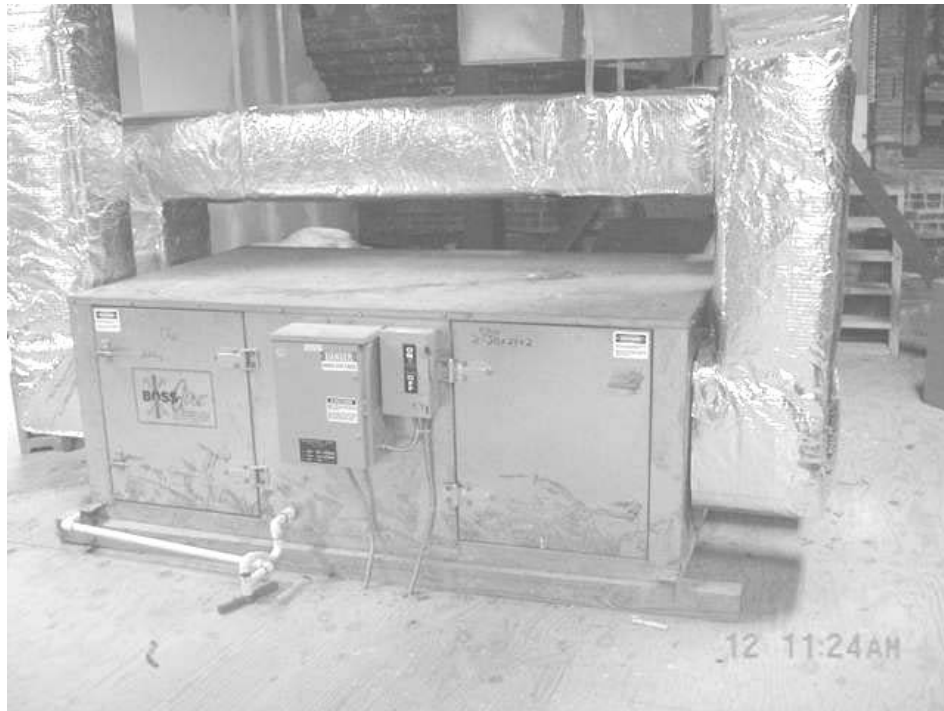
**Picture 1**

The building has a heating, ventilating and air conditioning (HVAC) system, which consists of three air handling units (AHUs) equipped with high efficiency pleated air filters (Pictures 1 and 2). Conditioned outside air is provided through ducted wall or ceiling vents and is returned to the AHUs by ducted ceiling-mounted return vents, which are also equipped with high efficiency-pleated filters (Picture 3) providing dual filtration. This system was operating throughout the building on the day of the assessment. Thermostats that control the HVAC system have fan settings of “on” and “automatic”. Thermostats set to the “automatic” setting were observed during the assessment (Picture 4). The automatic

**One of Three Air Handling (AHU) Units in the Attic**

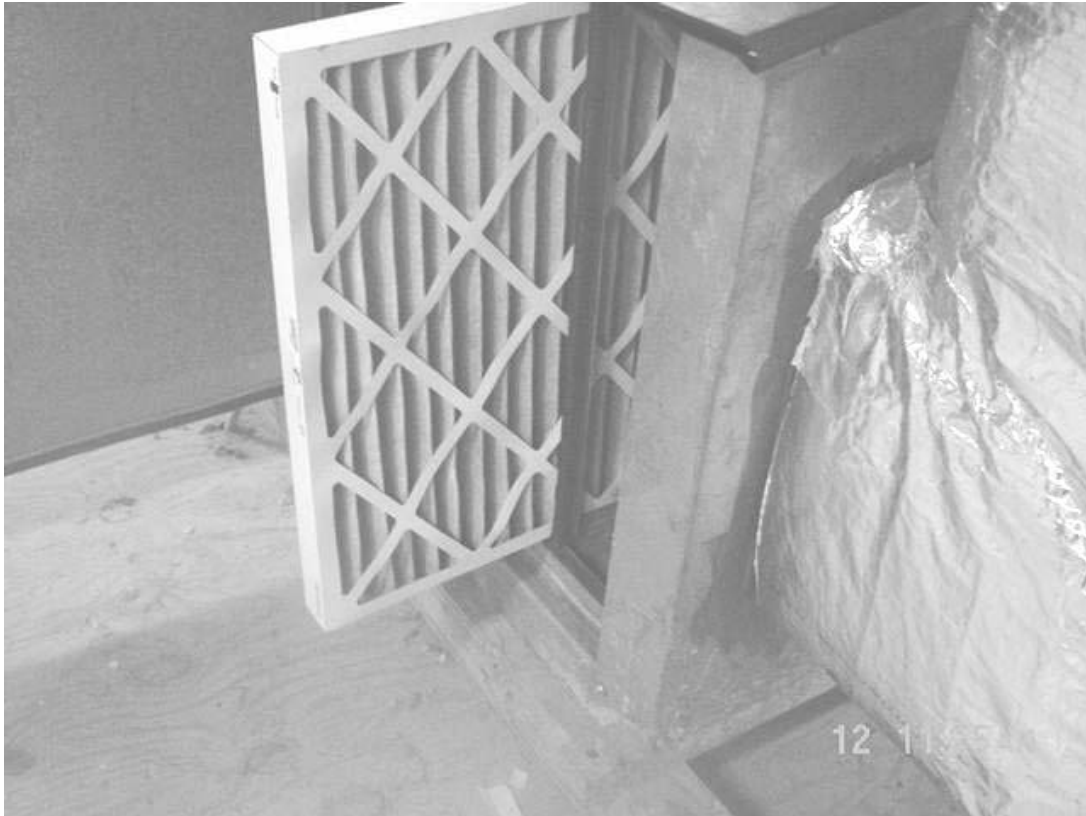
**Picture 2**

**High-Efficiency Pleated Air Filters for AHU**

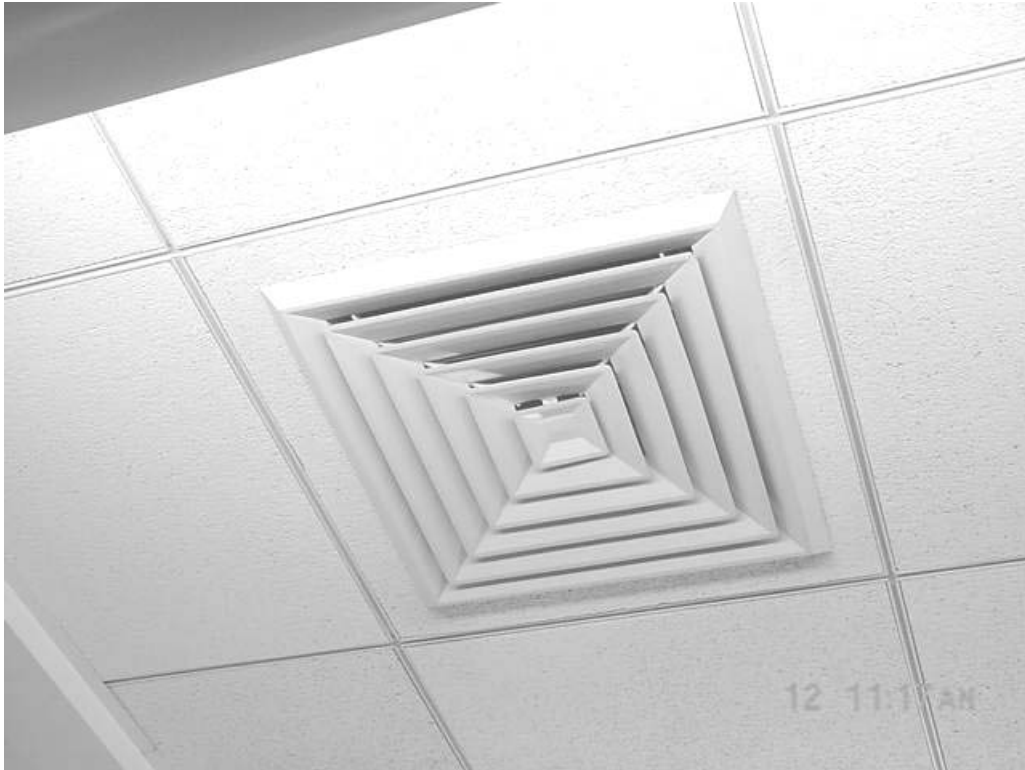
**Picture 3**

**Ceiling-Mounted Air Diffuser**

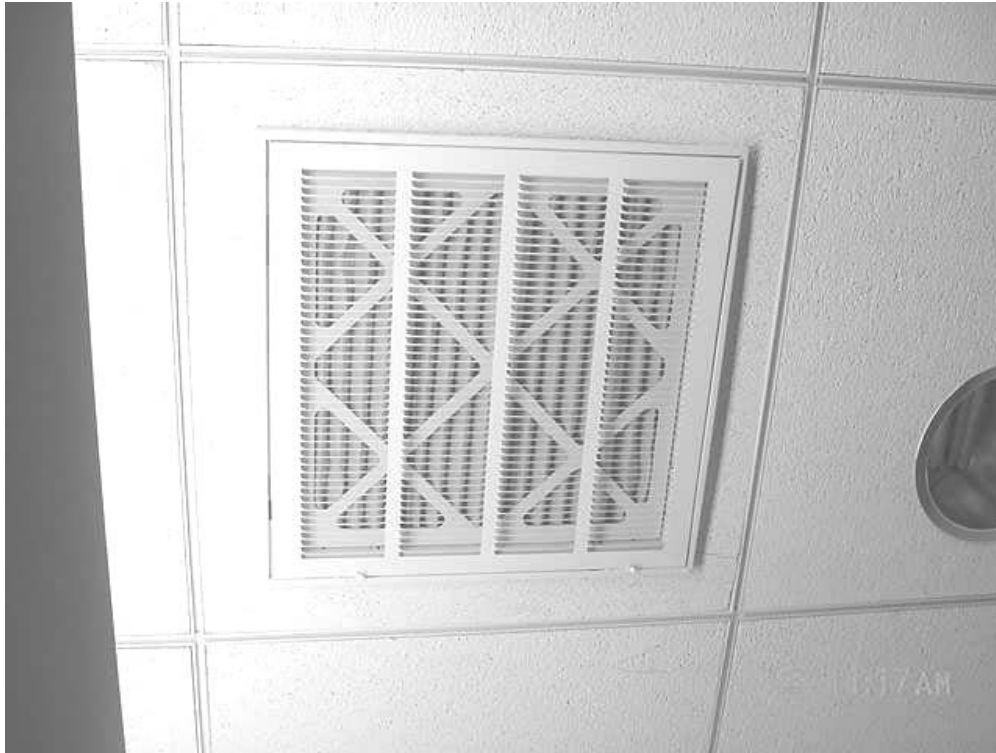
**Picture 4**

setting on the thermostat activates the HVAC system at a preset temperature. Once the preset temperature is reached, the HVAC system is deactivated. Therefore, no mechanical ventilation is provided until the thermostat re-activates the system.

**Ceiling-Mounted Return Vent With High Efficiency Pleated Air Filter**

To maximize air exchange, the MDPH recommends that both supply and exhaust ventilation operate continuously during periods of occupancy. In order to have proper ventilation with a mechanical ventilation system, the systems must be balanced to provide an adequate amount of fresh air to the interior of a room while removing stale air from the room. It is recommended that HVAC systems be re-balanced every five years (SMACNA, 1994). The date of the last systems balancing should have occurred when building renovations were completed in 1997. Ms. Winquist reported that DFL staff has been working with their HVAC vendor over the last year to rebalance the system, due to employee comfort issues.

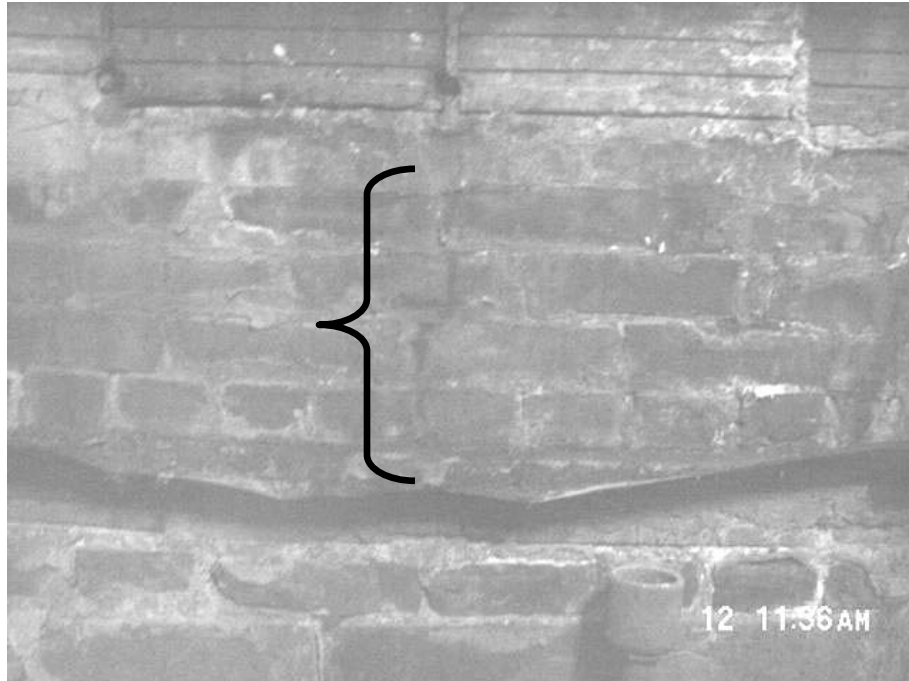
**Picture 5**

Water-damaged building materials (e.g., wood, gypsum wallboard/Pictures 5-9) and efflorescence were observed in the attic and on the second floor. Water damage is most likely the result of water penetration through the building envelope primarily on the north facing wall (Picture 10). Efflorescence is a characteristic sign of water damage to brick and mortar, but it is not mold growth. As moisture penetrates and works its way through mortar and brick, water-soluble compounds in mortar and brick dissolve, creating a solution. As the solution moves to the surface of the mortar or brick, the water evaporates, leaving behind white, powdery mineral deposits.

**Water Trickling Down Interior Brick Wall in Attic**

2. Replace any porous water-damaged building materials, once roof leaks are under control. Examine the area above and beneath these areas for microbial growth. Disinfect areas of water leaks with an appropriate antimicrobial. Clean areas of antimicrobial application when dry.

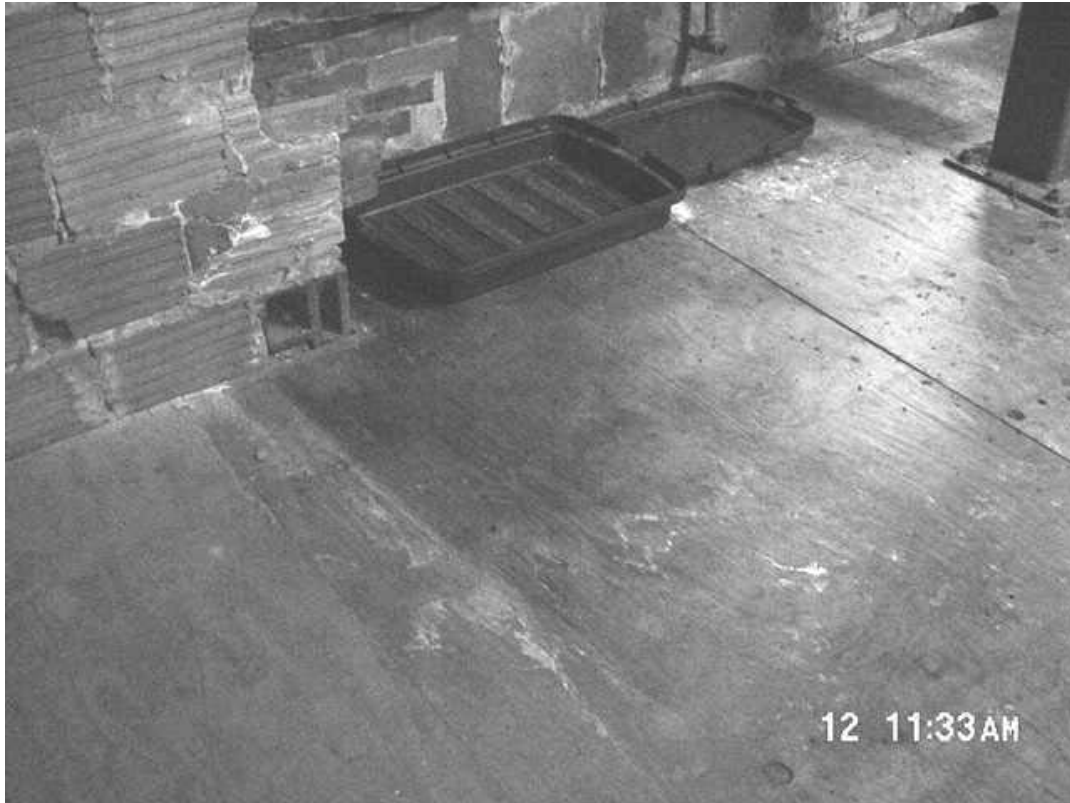
**Picture 6**

**Troughs Catching Water along North-Facing Wall in Attic, Note Water Damaged Floor Boards (Foreground)**

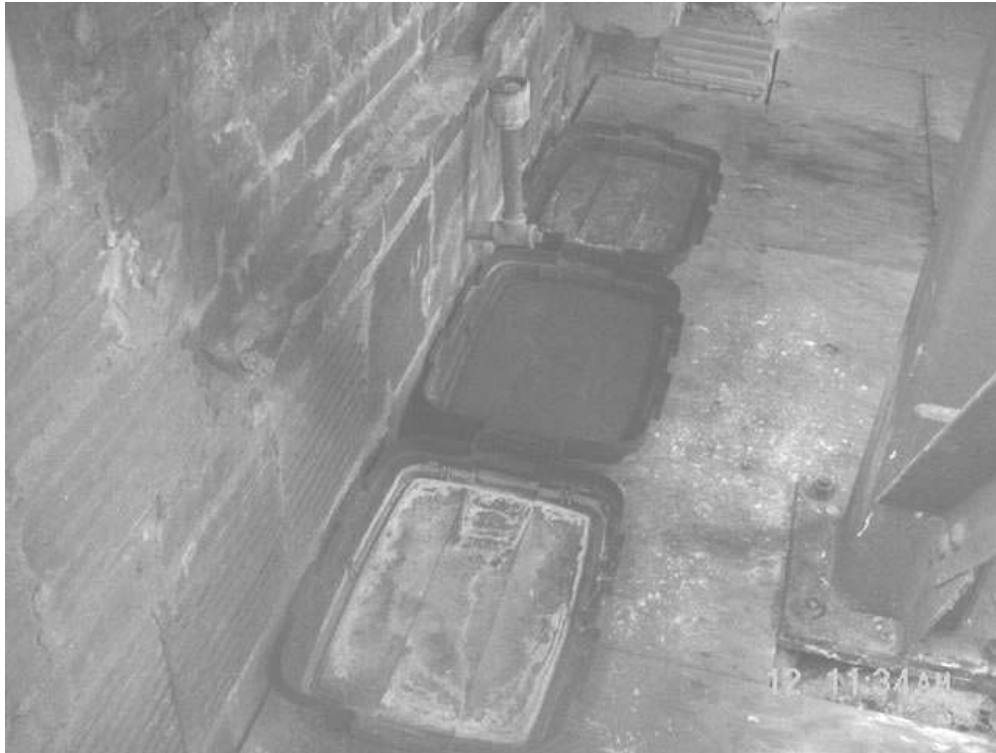
**Picture 7**

**Troughs Catching Water along North-Facing Wall in Attic,**

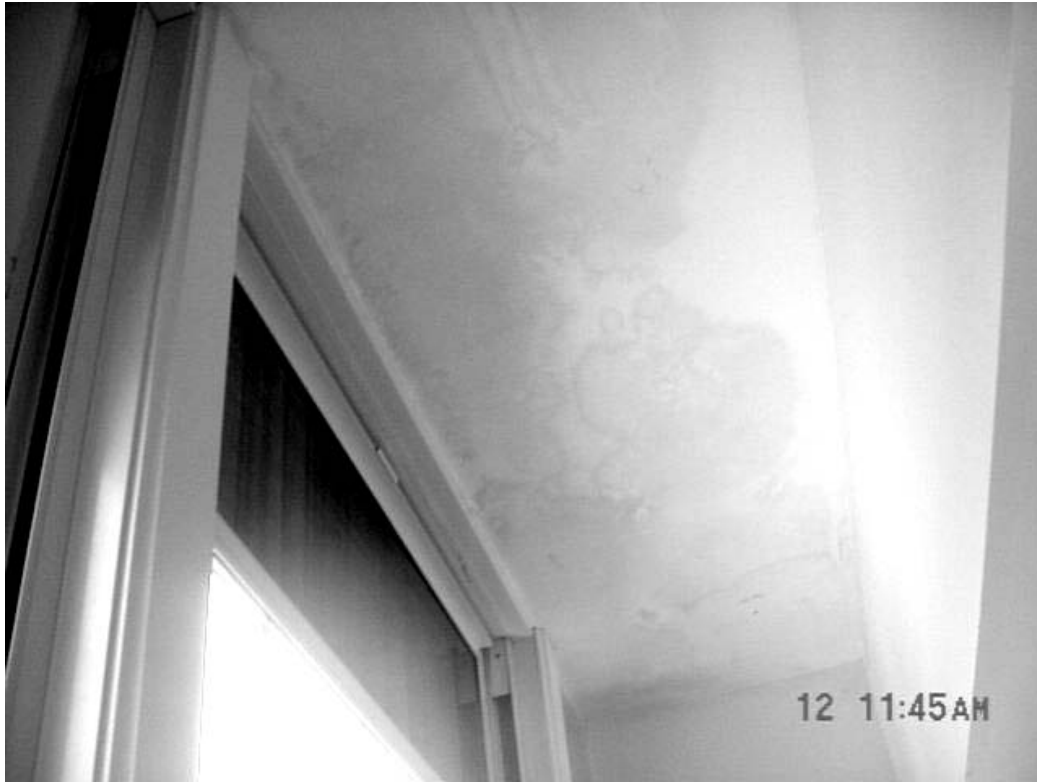
**Picture 8**

**Water Damaged Gypsum Wallboard Ceiling on Second Floor along North-Facing Wall**

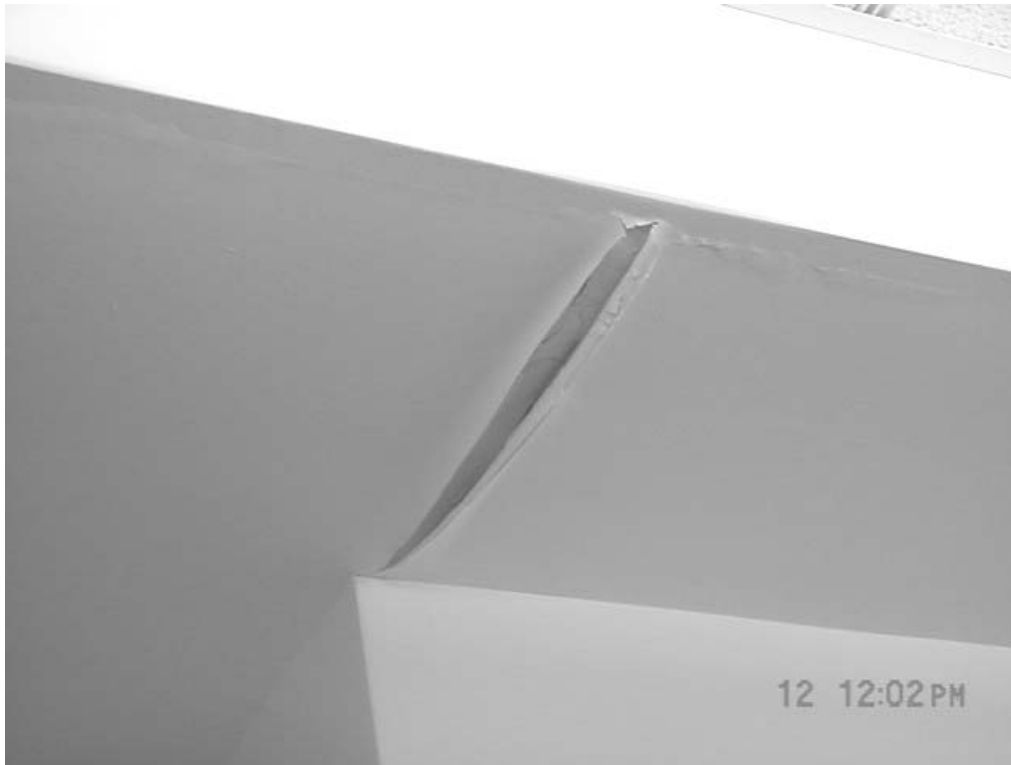
**Picture 9**

**Water Damage/Peeling Ceiling Paint on Second Floor along North-Facing Wall**

1. Consider repointing brickwork on the north-facing wall. Consider consulting an architect, masonry firm or general contractor regarding the integrity of the building envelope, primarily concerning water penetration through exterior walls. Ensure all leaks are repaired. Once leaks are repaired, repair water-damaged plaster/paint and examine the feasibility of repointing brickwork.

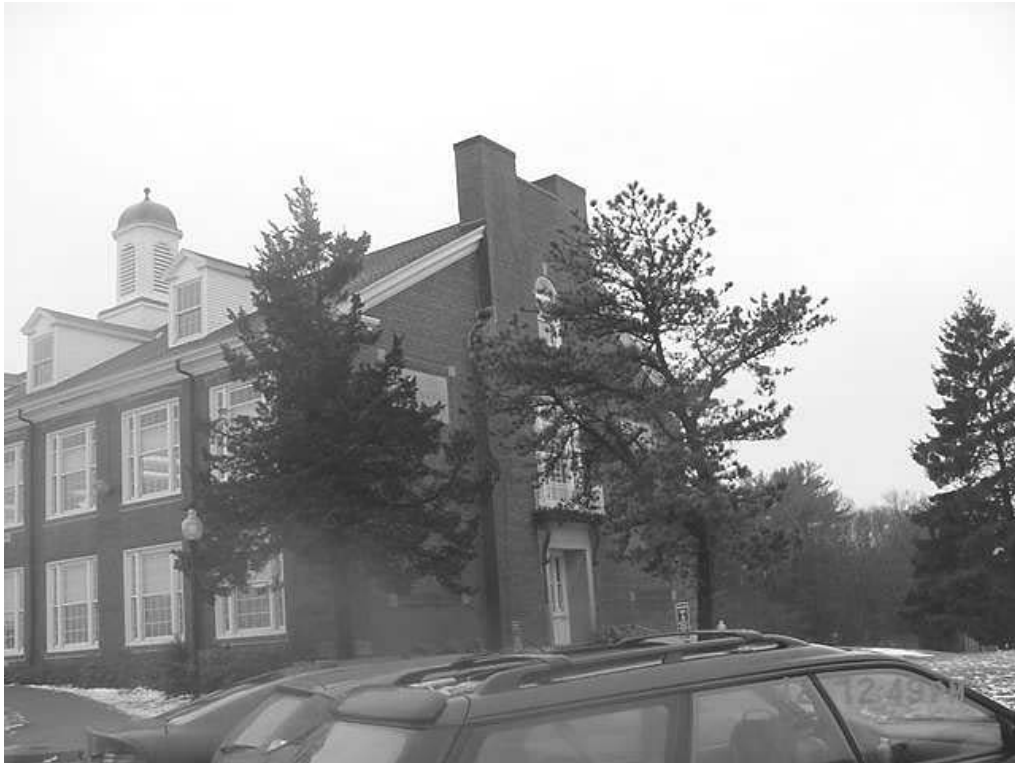
**Picture 10**

**Exterior View of North-Facing Wall**

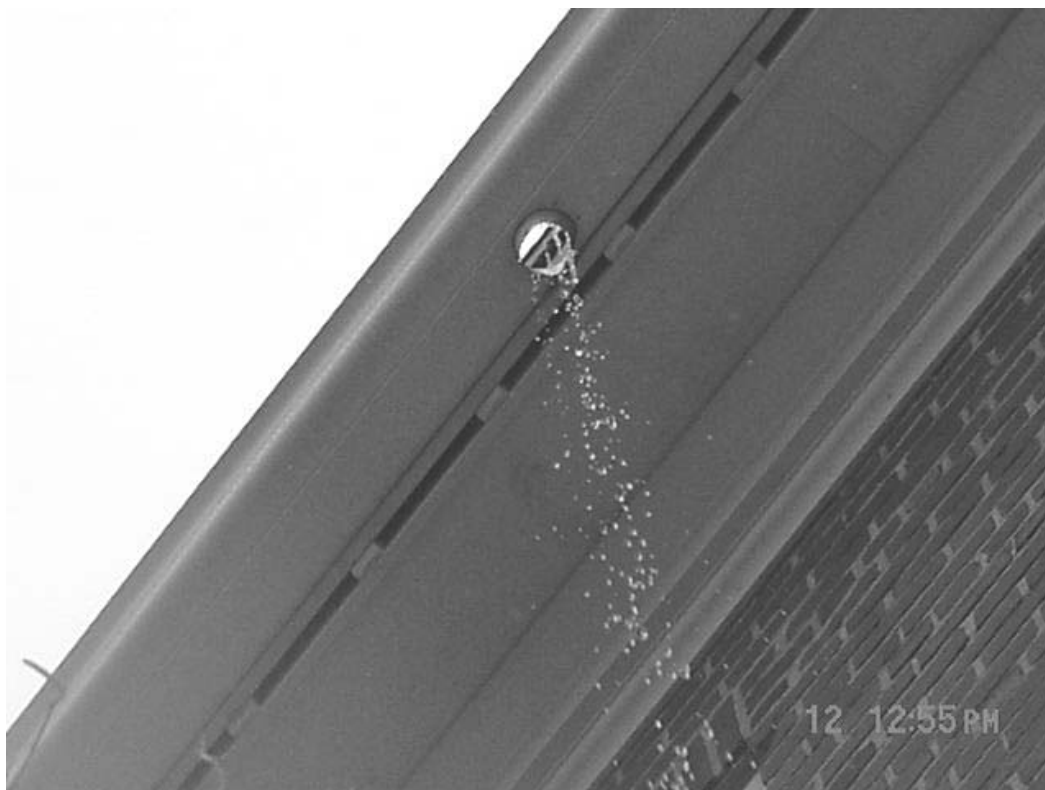
**Picture 11**

MDPH staff examined the building exterior and observed several downspouts missing from the drainage/gutter system (Picture 11 and 12). Pooling water and excessive exposure of exterior brickwork to water can result in damage over time. Mortar around exterior brickwork appeared to be crumbling or missing in some areas (Pictures 13 and 14). During winter weather, the freezing and thawing of moisture in bricks can accelerate the deterioration of brickwork. Damaged brickwork can become a point of water intrusion.

**Hole in Gutter/Missing Downspout**

3. Continue working with HVAC vendor to make adjustments to the mechanical ventilation system to improve the comfort of occupants.
4. Repair breaches in the building envelope including, cracks in walls and tarmac, missing/damaged flashing, and spaces around bulkheads. Consider replacing damaged wooden bulkhead with metal.

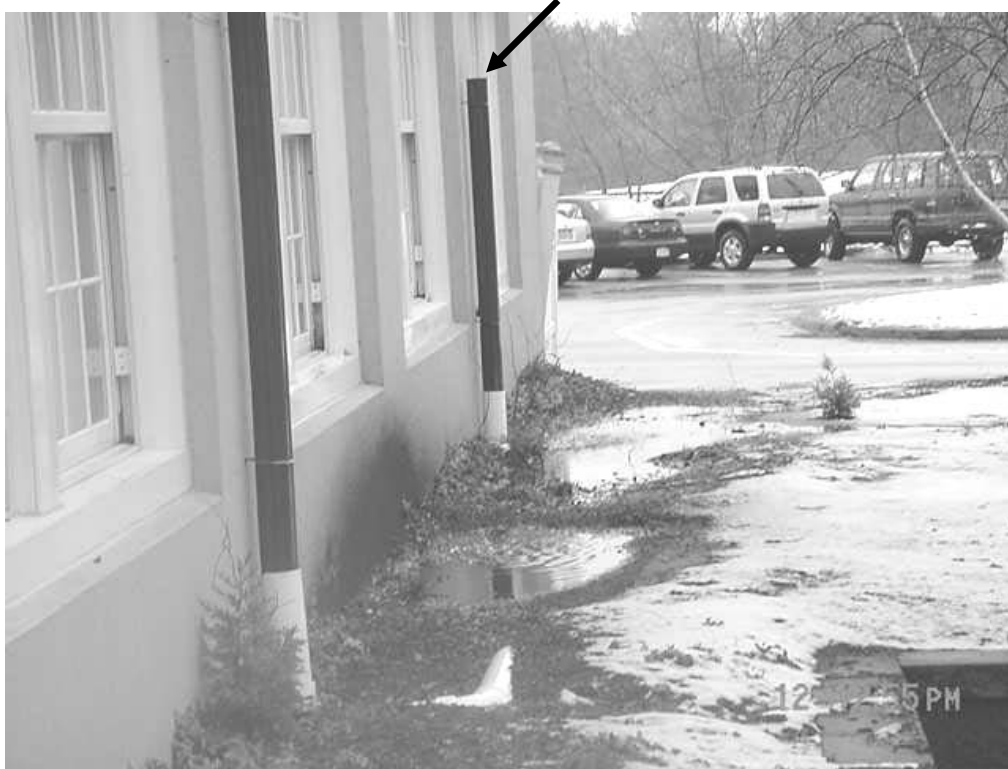
**Picture 12**

**Missing Section of Downspout and Water Pooling on Exterior of Building**

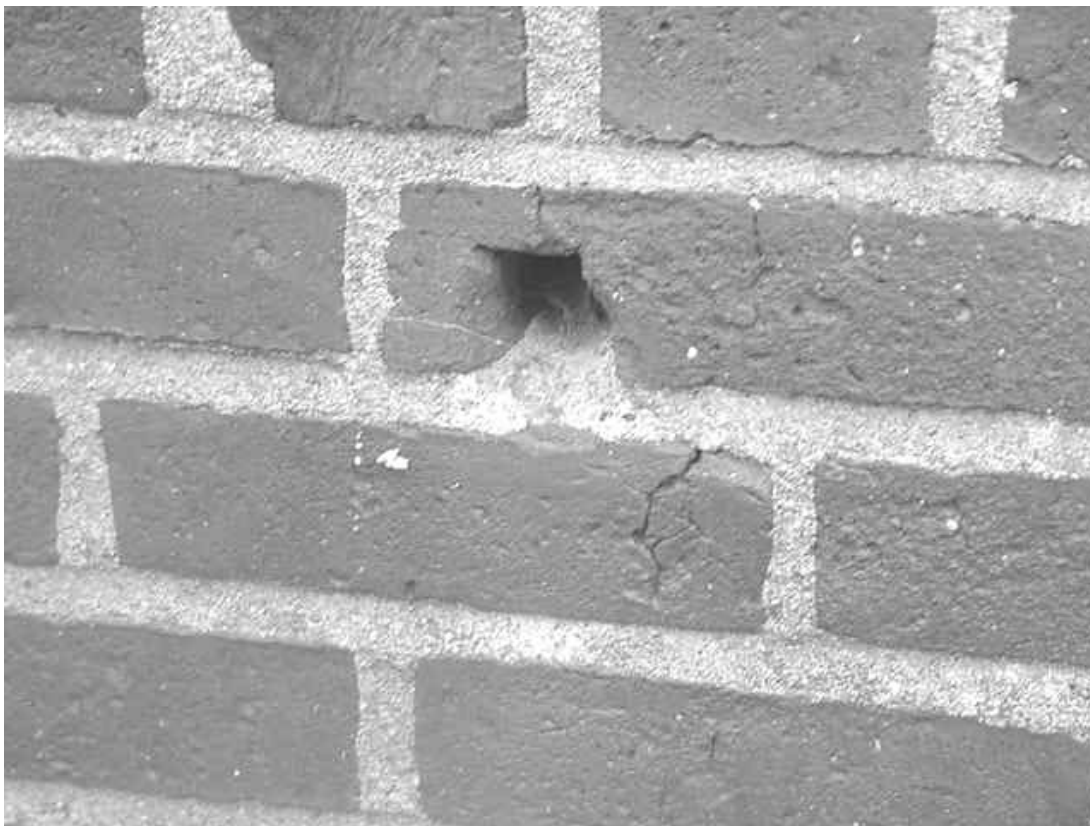
**Picture 13**

**Open Hole in Exterior Brick**

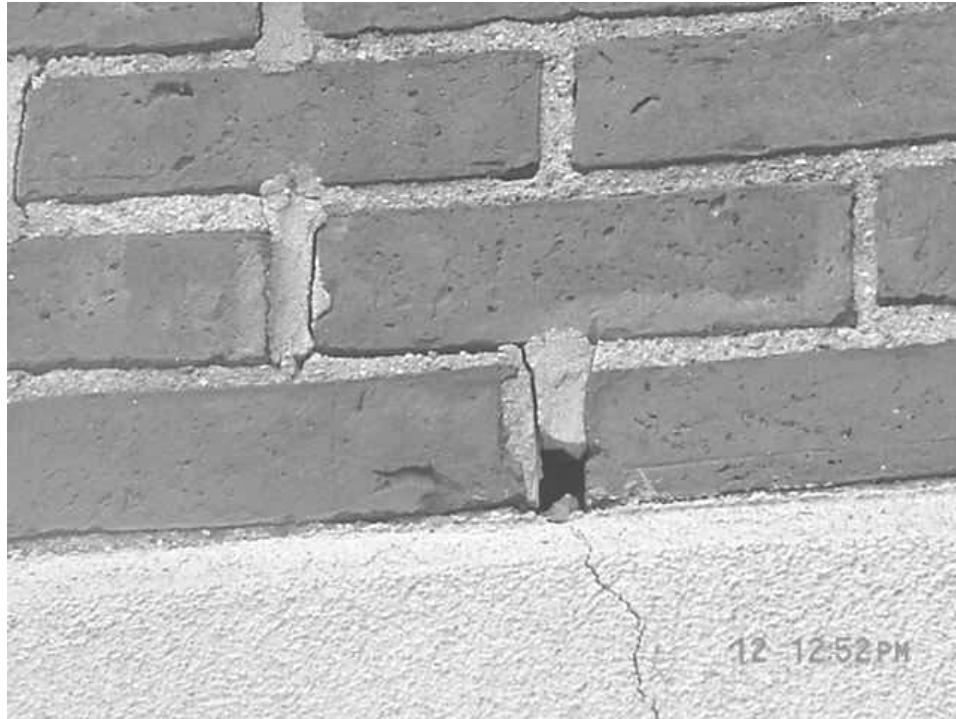
**Picture 14**

**Missing/Damaged Mortar around Exterior Brick**
